Manhole Inspection Summary

Manhole # S57G__010MH

Insp Date: **1/2/09 9:31 AM**

Location Address: **rear 3901 e pratt st**

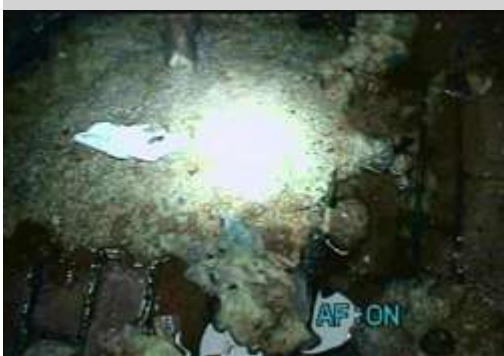
Defect 3

Condition: ☐ Sound ☐ Cracked ☐ Root Intrusion ☐ Deteriorated ☐ Leaks ☒ **Debris**

channel debris

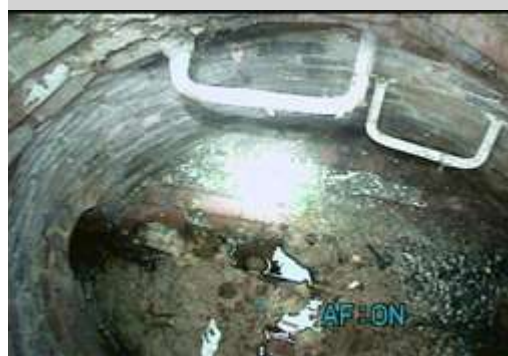
Defect 2

Steps Count: **2** Missing: **0** ☒ **Corroded**

steps corroded

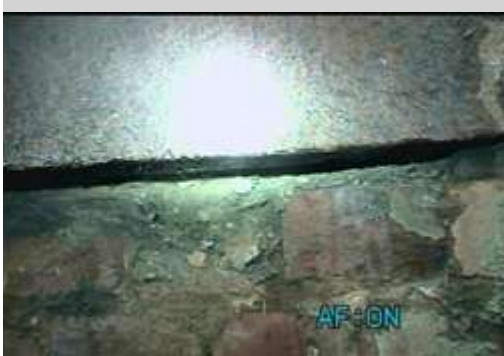
Defect 1

Condition: ☐ Sound ☐ Cracked ☐ Root Intrusion ☐ Loose Brick ☒ **Deteriorated**

chimney deteriorated at frame joint

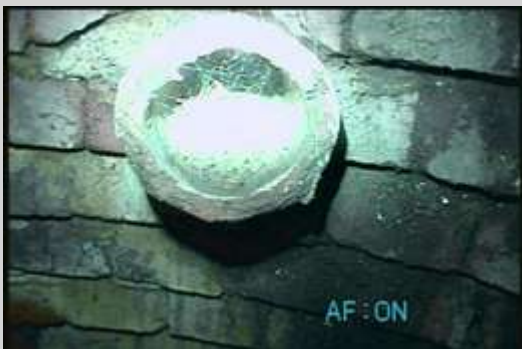
7 O'Clock Inflow

Deposits: ☐ None ☐ Mud ☐ Sludge ☒ **Debris** ☐ Grease

Silt Depth: 2.5 (in.) Deposits Extent: **Medium**
